Rowe CBA, CBA-2 UCBA-2 CBA-4 and UCBA-4s

An overview By Bruno D Puglia March 10, 2005 East Coast Amusements Canton, MA http://www.eastcoastamusements.com/

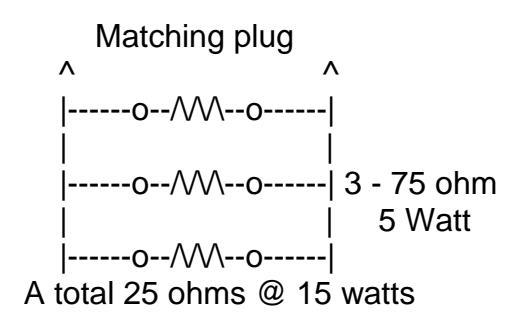
The power supply may appear to be just a transformer but there is a full wave bridge and a filter cap located with the transformer case. In the case of the COINCO CBA-2 supply there is addition electronics located with the transformer case for interface circuits. If you decide to swap a CBA-2/UCBA transformers, a voltage test should be made first. If the power supply is bad, you might BLOW the second CBA-2 or UBA. Always check the voltage and AC ripple voltage before attaching a power supply transformer to a CBA-2/UCBA-2. To do a stand alone voltage test a resistor load of 25 ohms at 15 watts can be made from three (3) 75 ohm, 5 watt resistors.

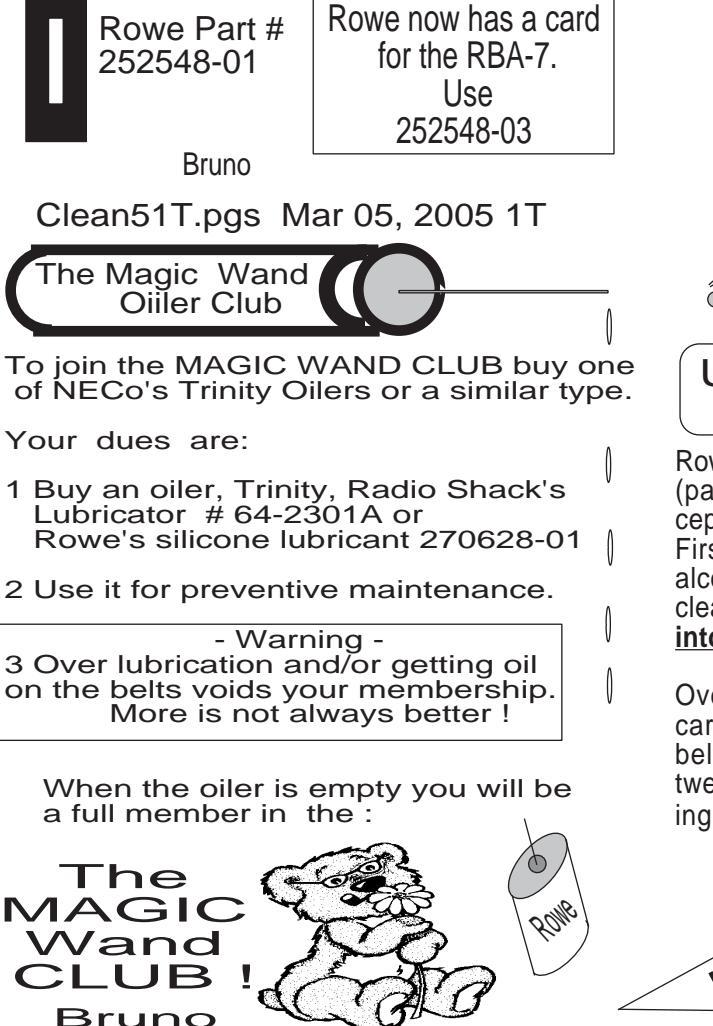
Cleaning Mag Head Pressure Rollers

Rowe has designed a card using paper and thin double sided tape to clean ink, dirt, and other containants off the magentic head pressure rollers. The one sticky side is attached to the paper and when you are ready to use the card remove the protctive aper to expose the sticky tape. Then stick the card into the acceptor. While the cards were made for the BA50 acceptor they can be used on all Rowe acceptors (except the RBA-7) and other acceptors. Some aceptorts do not pull the paper into the acceptor so you will have to hand crack the acceptor. People who have seen me work know I always use tape to clean the roller/s under the magnetic head/s.

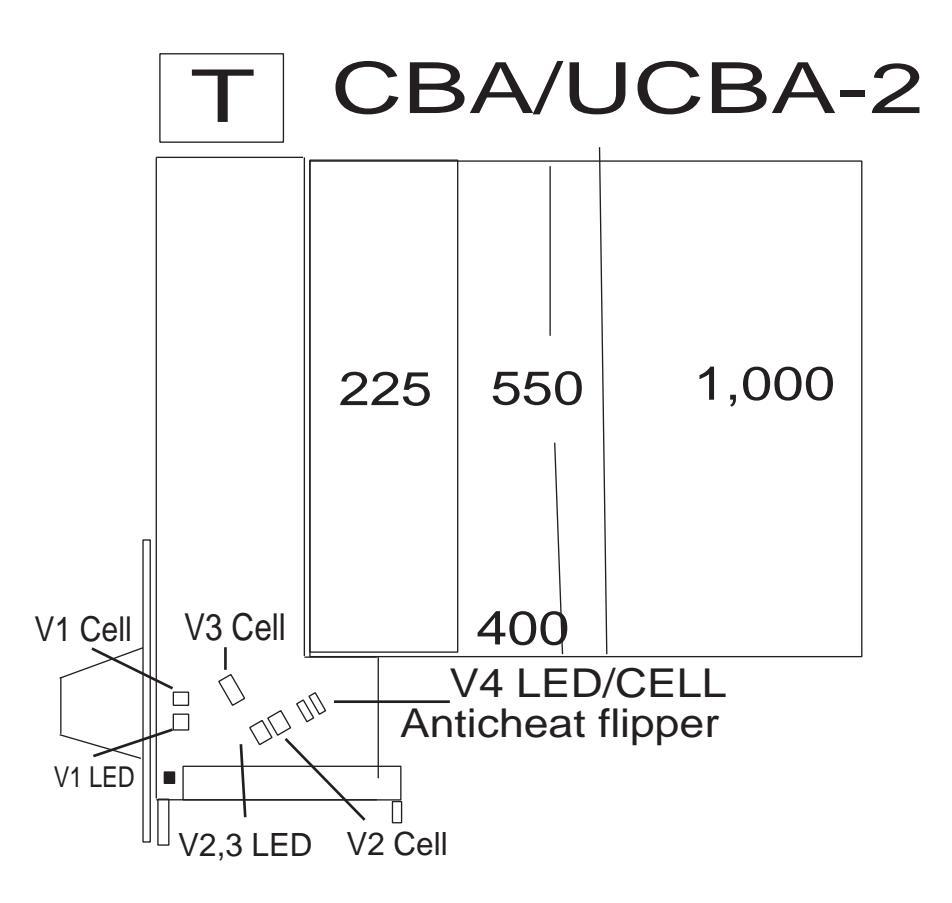
V1 LED is on the bottom and hits V1 cell on the top. The V2,V3 LED is mounted on the lower cell assembly board and supplies light to V3 cell mounting in the Mag head assembly. This same LED suuplies the light which is reflected from the back side of the bill to the V2 cell mounted the lower cell assemby board. Errors or problem will be notied with the number of status blinks

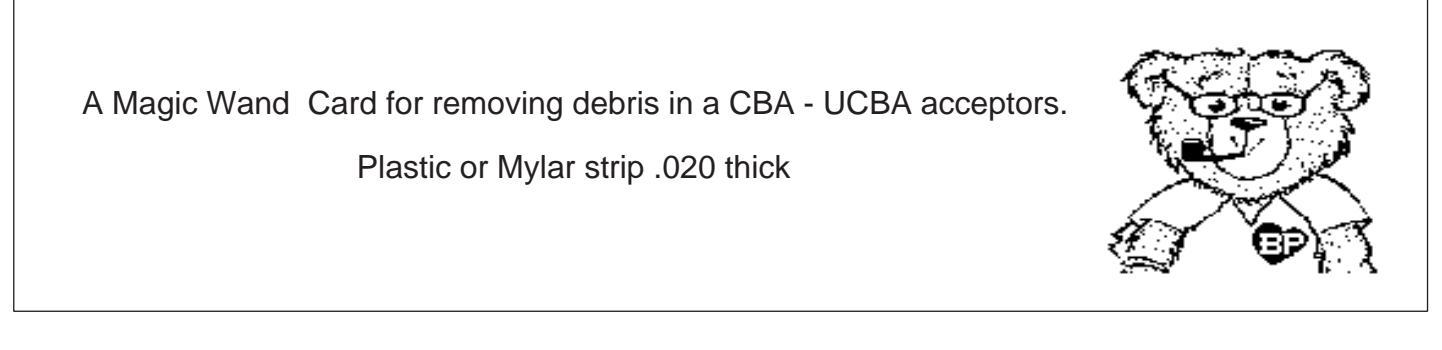
The mylar or plastic strip procedure presumes the tracks has not been damaged by sharp objects. If a worst case condition exists and you cannot get the tracks clear, the acceptor has to come apart. I hope you have a spare ! The mylar strip I use is actually a old juke box label strip. They are no longer available but we have a few left. Part # 3-65271-01. An alternative might be a plastic book marker sold in some book stores. You want to end up with a .020 thick strip which is about 1 5/8" wide and 7 1/2" long. You can make your own strip.
